MFL-08-01 Data Sheet

MFL-08-01 is the newest high resolution tool. It has the next generation of magnetic flux leakage (MFL) pipeline inspection technology that features the industry's highest density and most powerful sensor combination. This high-resolution MFL inspection tool utilizes axial pipe magnetization and is optimized to detect and accurately measure pipeline anomalies. The caliper section has a unique design that fully covers the inside circumference of the pipe.

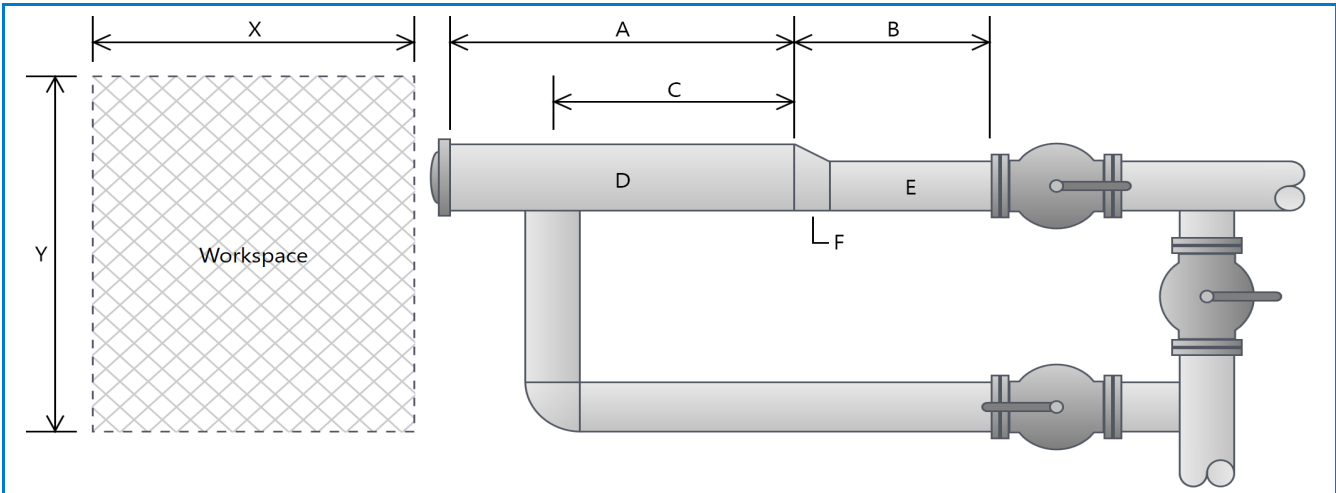
Launcher & Receiver Information

Label	Description	Launcher	Receiver	Units
A	Oversize Length			in
B	Nominal Length			in
C	Reducer To Kicker Line			in
D	Oversize Diameter	NPS 8	NPS 8	
E	Nominal Diameter	NPS 6	NPS 6	
F	Reducer Type	Eccentric	Eccentric	
X	Workspace Length			in
Y	Workspace Width			in
